Bodie Island Lighthouse Historic Structure Report

BODIE ISLAND
LIGHTHOUSE & OIL HOUSE

HISTORIC STRUCTURE REPORT

**Cultural Resources Division
Southeast Regional Office
National Park Service
December 2004**

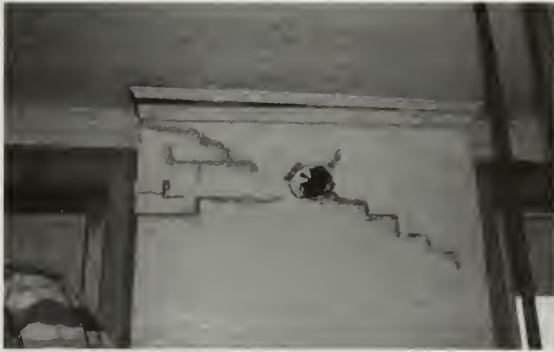
Figure 8 1989 USCOE photo showing cracked masonry in Oil Room interior chimney.

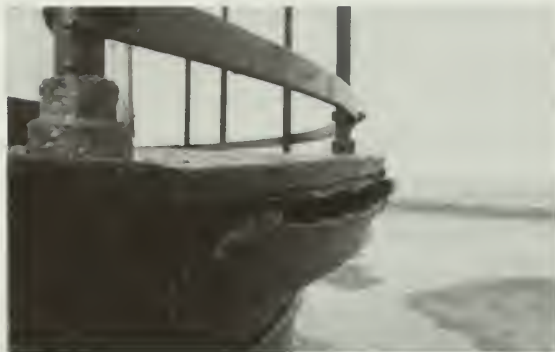
Figure 9 1989 USCOE photo showing deterioration of exterior edge of lantern gallery.

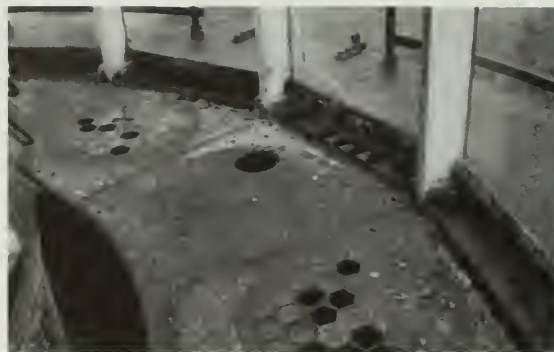
Figure 10 1989 USCOE photo showing missing lantern deck prisms.

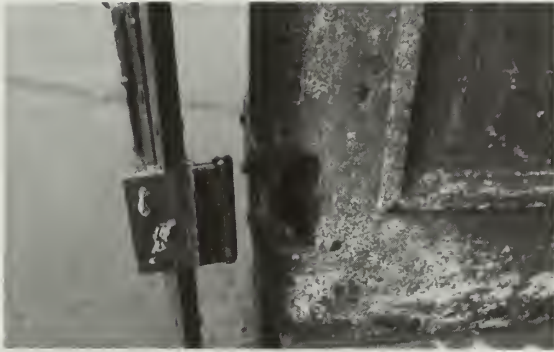
Figure 11 1989 USCOE photo showing detached hinge on door to gallery.

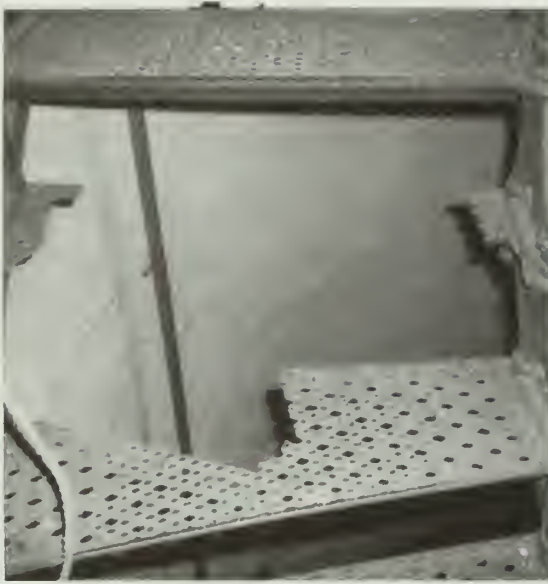
Figure 12 USCG close-up photograph of damage to stair treads, 1992.

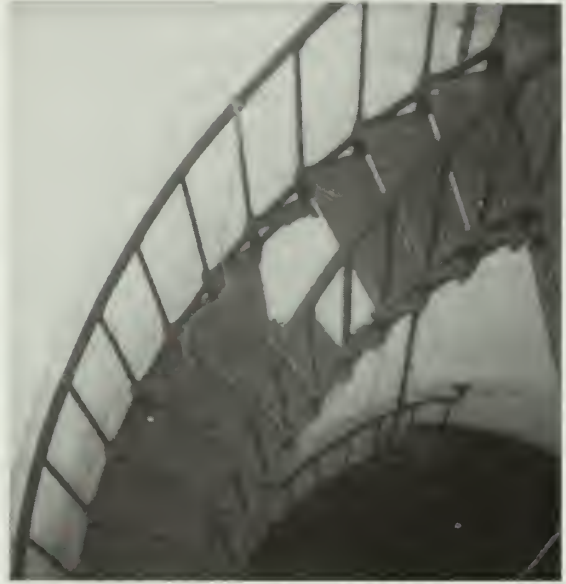
Figure 13 USCG photograph of damage to stair treads, 1992.

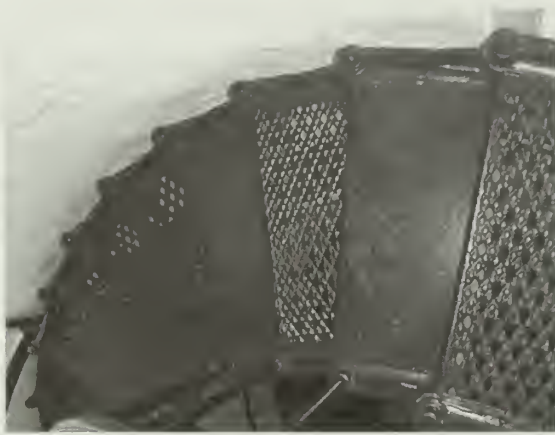
Figure 14 Existing repairs to stair treads.

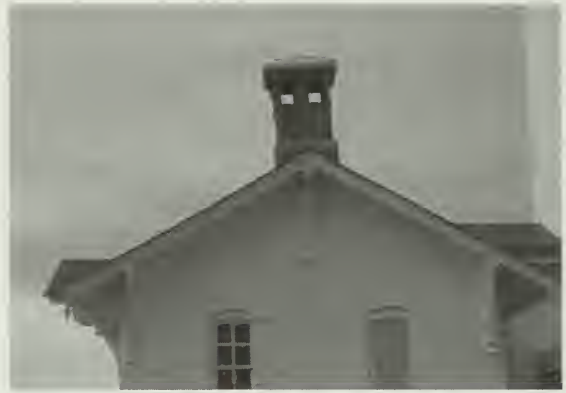
Preservation efforts in these areas should include removal of damaged materials only and replacement to match existing. There was no

Figure 28 South chimney above the Oil Room.

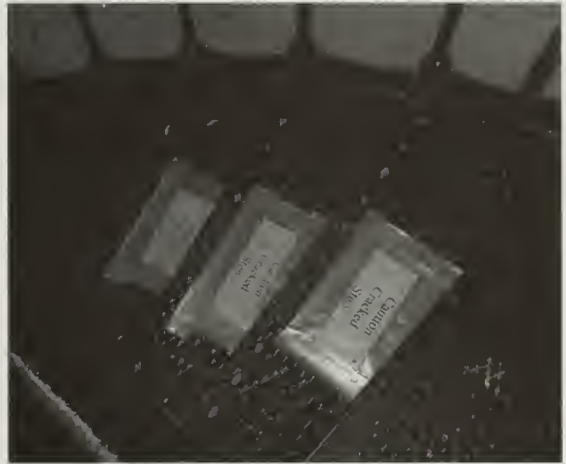
Figure 29 Three treads with notable cracks, below Landing #1.

- Implement a systematic program to open the windows regularly to provide ventilation and reduce moisture condensation on the interior of the Tower.
- Implement a systematic program to inspect the underside of the stair treads for future stress cracks.

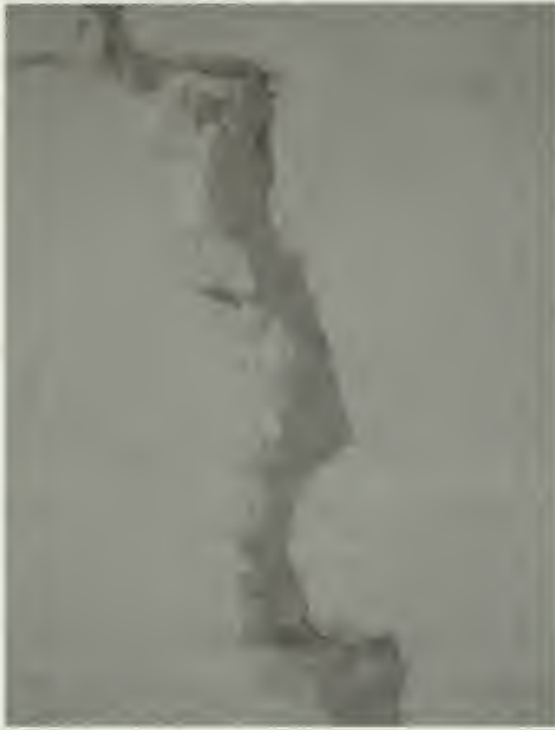
Figure 30 Detail of vertical crack on south side of masonry wall.

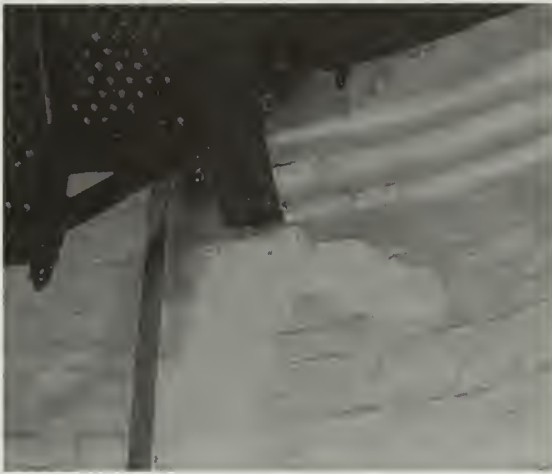
Figure 31 Detail of masonry repair located above landing support beam.

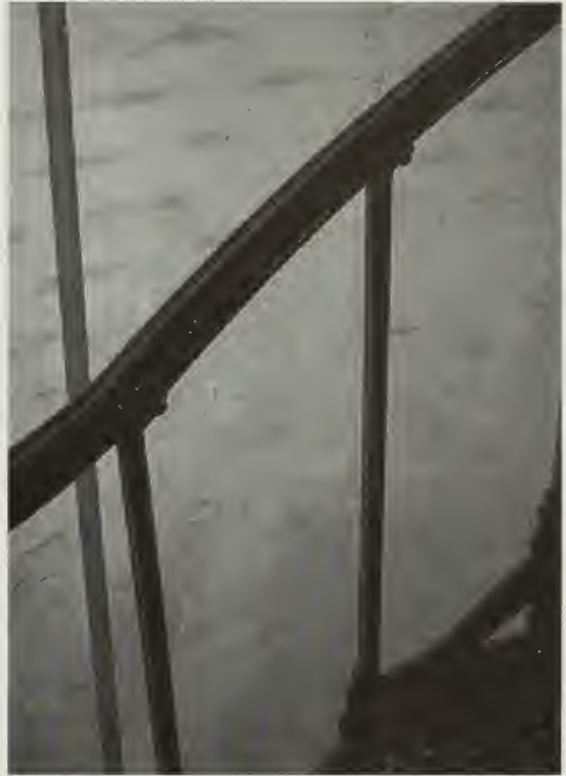
The exterior gallery was not analyzed for public access. Visual observation of the condition of the surface and supports indicates that considerable strengthening of the gallery members would be required before visitors could safely be allowed on the gallery. Such strengthening would include re-fabrication of missing and deteriorated parts, both of the ornamental ironwork and structural components such as

Figure 35 Detail of handrail.

- Install a new, code-compliant railing around the existing exterior gallery.
- Modify the stair and landing level railings to provide fall protection.
- Install bracing on each side of stairs, mid-flight, to bring the stair stringers up to code.
- Install fall protection at the openings to the windows on the 2nd, 5th, and 8th level landings.
- Fabricate and install a railing conforming to current code requirements at the stair from the Watch Room level to the Lamp level.
- Remove the chain link enclosure at the base of the Tower stairs and repair the walls and floor of the ground level of the Tower as necessary.

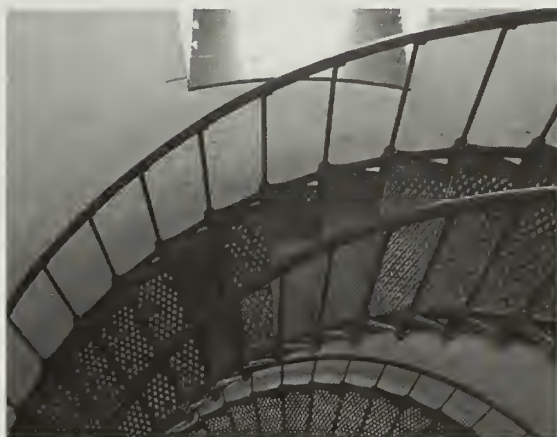
Figure 43 Detail of stair showing tread repair.

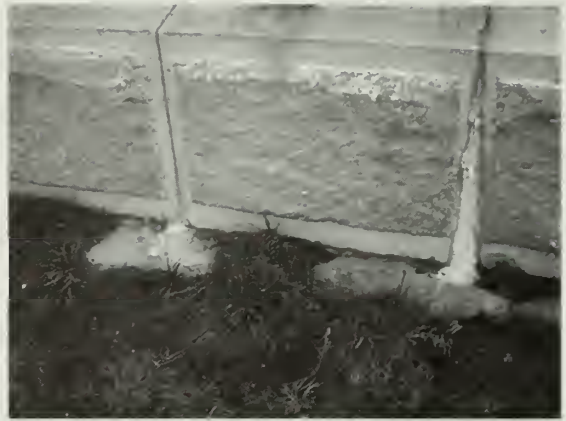
Figure 44 Detail of foundation showing mortar leaching.

- Perform tests on the mortar to determine its composition and repoint the foundations and walls using appropriate methods and mortars.
